Achieving home ownership was the end of one long and difficult journey, and it was the beginning of another – repairing the home of Rotary’s founder so it could be used by future Rotarians. Repairs are now halted while we compile and issue this report to our fellowship members regarding the severity of the struggle to repair, furnish, and maintain **Comely Bank**.

This fellowship, and the **Harris Home Foundation** that we established, acquired the home of Paul & Jean Harris known as **Comely Bank** in time to host a wonderful series of Centennial events including a ribbon cutting by RI’s Centennial President. Resuming our founder’s custom, commemorative trees were added beside those Paul had planted. *(continued next page)*

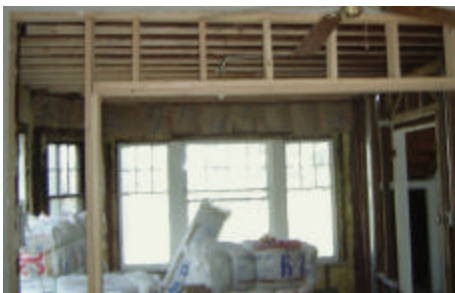
Looking into the dining room from the family room. Dining room cabinets have been removed to restore the bay window to its original size.

Harris Home interior snapshots taken a few days ago appear on this page and on page 5. As you can see, we cannot host any tours or events this month. We find ourselves managing a major reconstruction effort to bring the home up to modern standards and for safety reasons. We started to remove dining room cabinets that had been added after the Harris family sold the house. They hid two thirds of the bay window on the North side of the house. In doing this we discovered that someone had put sheetrock on top of lathe and plaster. The danger was that over time sheetrock will pull the plaster from the lathe. Professional home inspectors told us that over time the plaster, lath and sheetrock might cause the ceilings to cave in under the combined

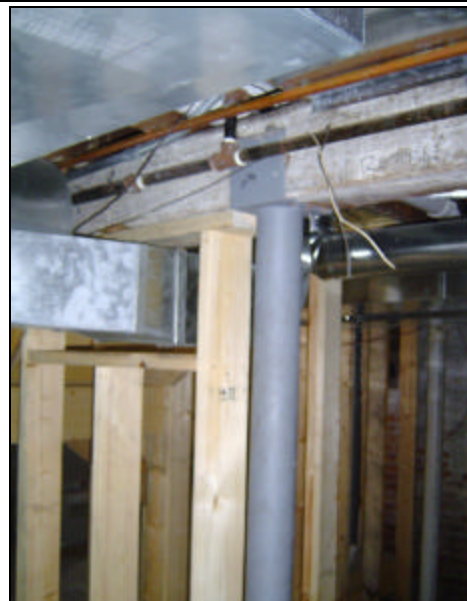
Since its construction in about 1912 the first floor had dropped nearly 2 inches. This was corrected by installing these new steel posts in the basement.

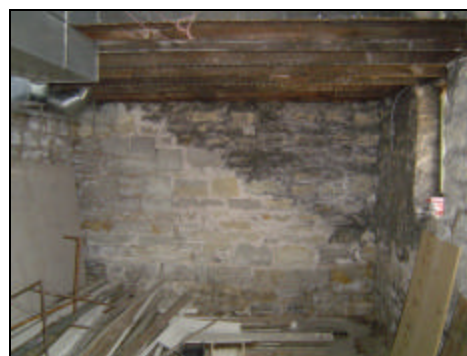
This photo was taken earlier this month. It shows the part of the basement beneath the sun porch seen in the 1940’s photo above.

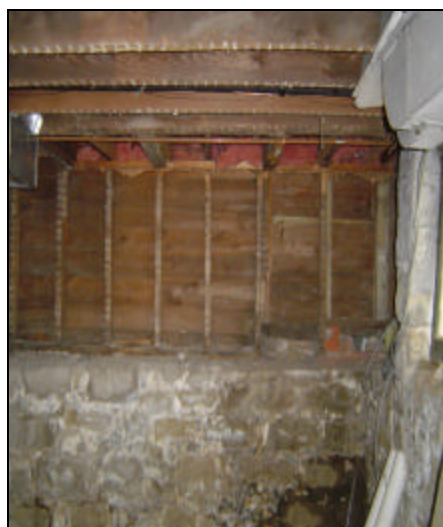
This basement view shows wooden studs resting on the original stone foundation walls.
